REPORT ON GEOTECHNICAL INVESTIGATION

GARDENS TENNIS – TENNIS COURT CRACKING ASSESSMENT

Reference: U23991

29 March 2016

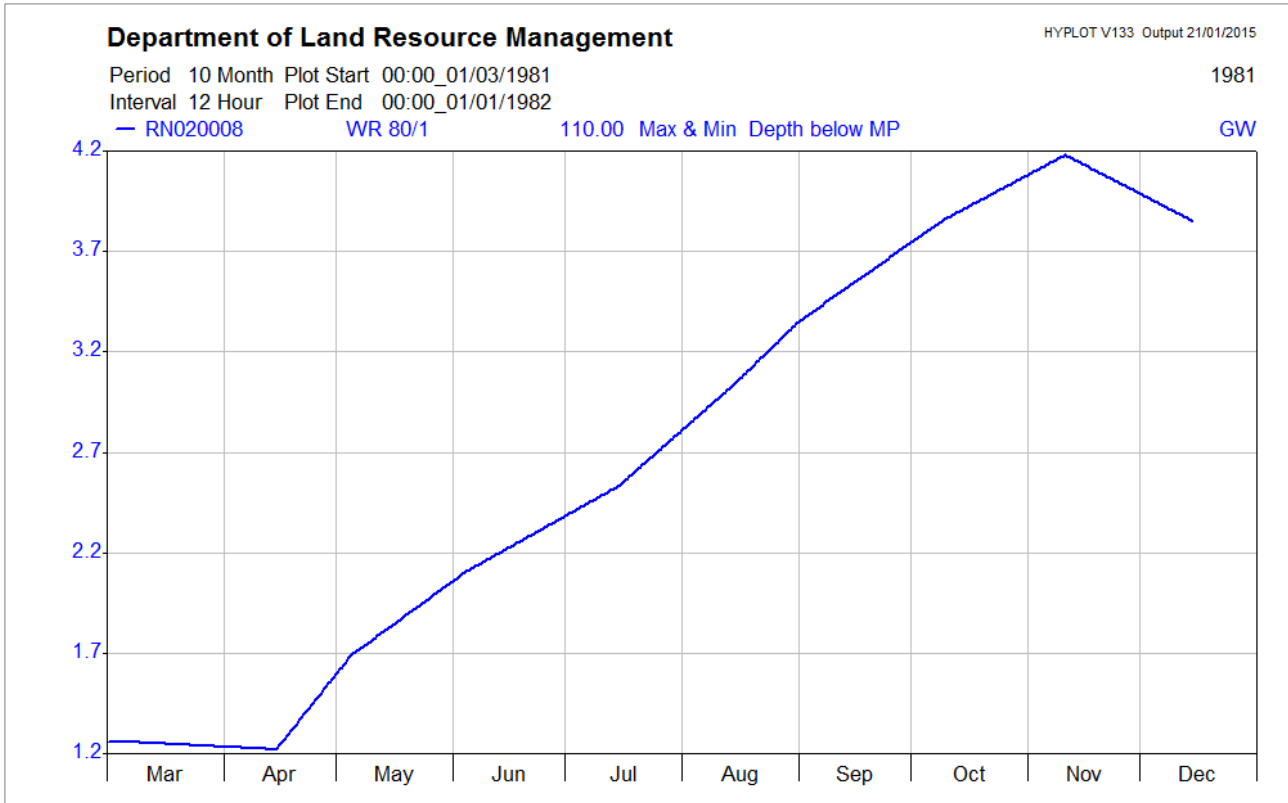
Figure 3: Recorded groundwater levels for registered well RN020008 between March and December 1981 (Department of Land Resource Management, www.lrm.nt.gov.au)

This is considered a typical groundwater depth curve for this part of Darwin. However, some wet seasons can be heavier resulting in protracted shallower depths.

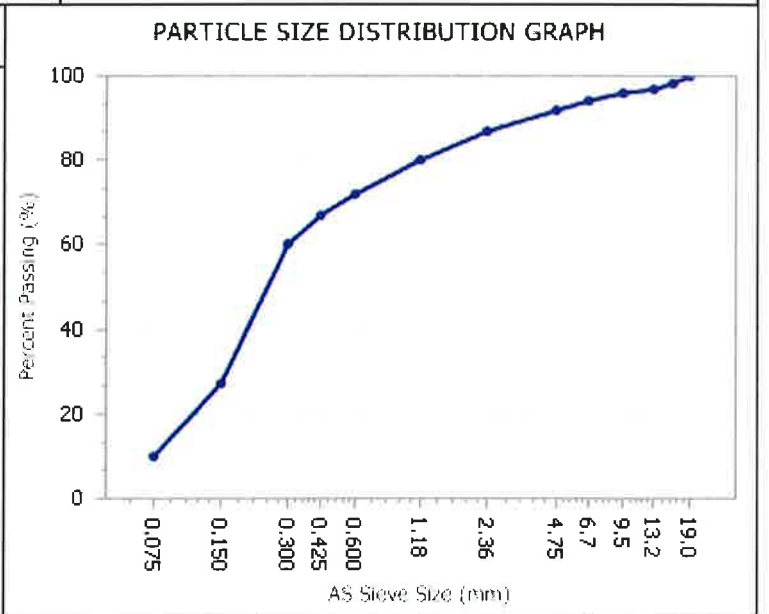
AS Sieve (mm)	Specification Minimum	Percent Passing (%)	Specification Maximum
19.0		100	
16.0		98	
13.2		97	
9.5		96	
6.7		94	
4.75		92	
2.36		87	
1.18		80	
0.600		72	
0.425		67	
0.300		60	
0.150		27	
0.075		10

Test Result	Specification Minimum	Result	Specification Maximum	Test Result	Specification Minimum	Result	Specification Maximum
Liquid Limit (%)		33		0.075/0.425 Fines Ratio		0.15	
Plastic Limit (%)		25		PI x 0.425 Ratio (%)		536.0	
Plastic Index (%)		8		LS x 0.425 Ratio (%)		234.5	
Linear Shrinkage (%)		3.5		Particle Size Dist. Moisture Content (%)		27.1	
Linear Shrinkage Defects	Crack

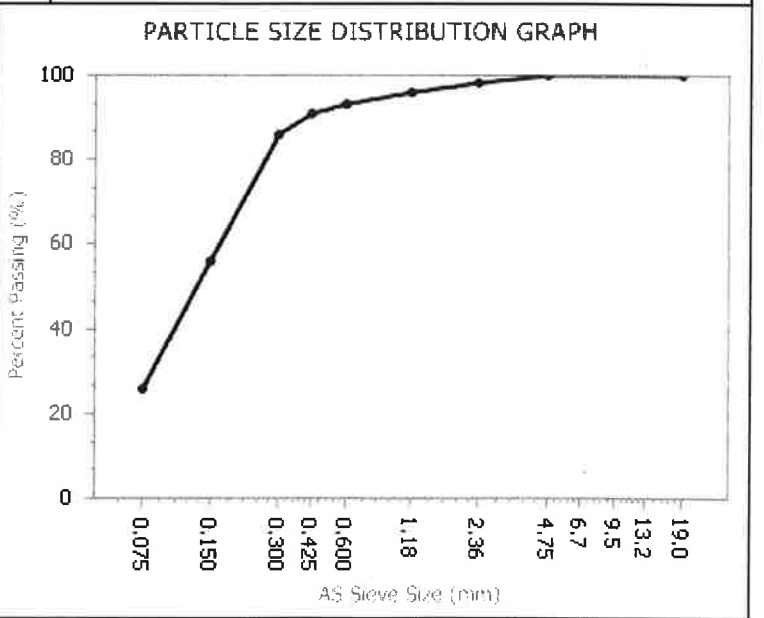
AS Sieve (mm)	Specification Minimum	Percent Passing (%)	Specification Maximum
19.0		100	
4.75		100	
2.36		98	
1.18		96	
0.600		93	
0.425		91	
0.300		86	
0.150		56	
0.075		26

Test Result	Specification Minimum	Result	Specification Maximum	Test Result	Specification Minimum	Result	Specification Maximum
Liquid Limit (%)		Not Obtainable		0.075/0.425 Fines Ratio		0.29	
Plastic Limit (%)		Not Obtainable		PI x 0.425 Ratio (%)		-	
Plastic Index (%)		Non Plastic		LS x 0.425 Ratio (%)		0.0	
Linear Shrinkage (%)		0.0		Particle Size Dist. Moisture Content (%)		24.2	
Linear Shrinkage Defects		-

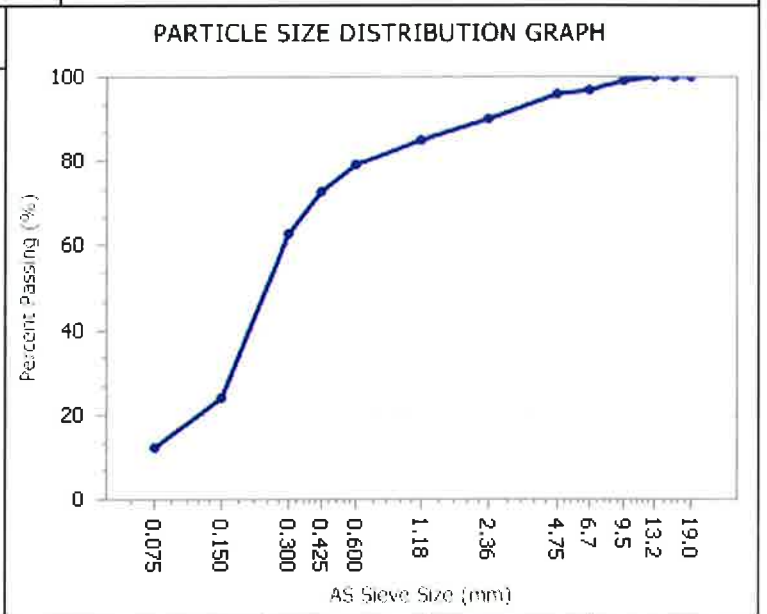
AS Sieve (mm)	Specification Minimum	Percent Passing (%)	Specification Maximum
19.0		100	
16.0		100	
13.2		100	
9.5		99	
6.7		97	
4.75		96	
2.36		90	
1.18		85	
0.600		79	
0.425		73	
0.300		63	
0.150		24	
0.075		12

Test Result	Specification Minimum	Result	Specification Maximum	Test Result	Specification Minimum	Result	Specification Maximum
Liquid Limit (%)		Not Obtainable		0.075/0.425 Fines Ratio		0.16	
Plastic Limit (%)		Not Obtainable		PI x 0.425 Ratio (%)		-	
Plastic Index (%)		Non Plastic		LS x 0.425 Ratio (%)		0.0	
Linear Shrinkage (%)		0.0		Particle Size Dist. Moisture Content (%)		16.7	
Linear Shrinkage Defects		-

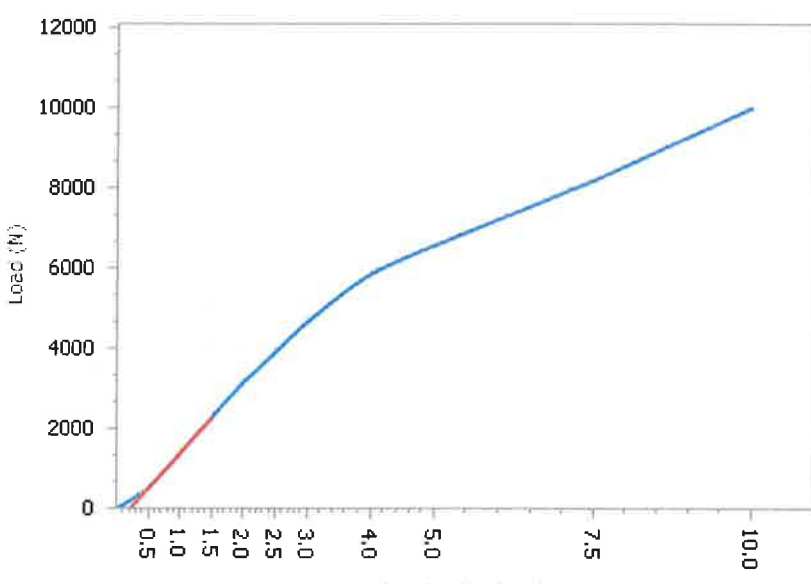
</div>
Optimum Moisture Content (%):	14.0	
Field Moisture Content (%):	16.7	
Sample Percent Oversize (%):	0.0	
Oversize Included / Excluded	Excluded	
Target Density Ratio (%):	95	
Target Moisture Ratio (%):	100	
Placement Dry Density (t/m ³):	1.78	
Placement Dry Density Ratio (%):	94.5	
Placement Moisture Content (%):	14.1	
Placement Moisture Ratio (%):	99.5	
Test Condition / Soaking Period:	Soaked / 4 Days	
CBR Surcharge (kg)	4.5	
Dry Density After Soak (t/m ³):	1.77	
Moisture (top 30mm) After Soak (%):	17.1	
Moisture (remainder) After Soak (%):	16.6	
CBR Swell (%):	0.0	
Minimum CBR Specification (%):	-	
CBR Value @ 5.0mm (%):	35

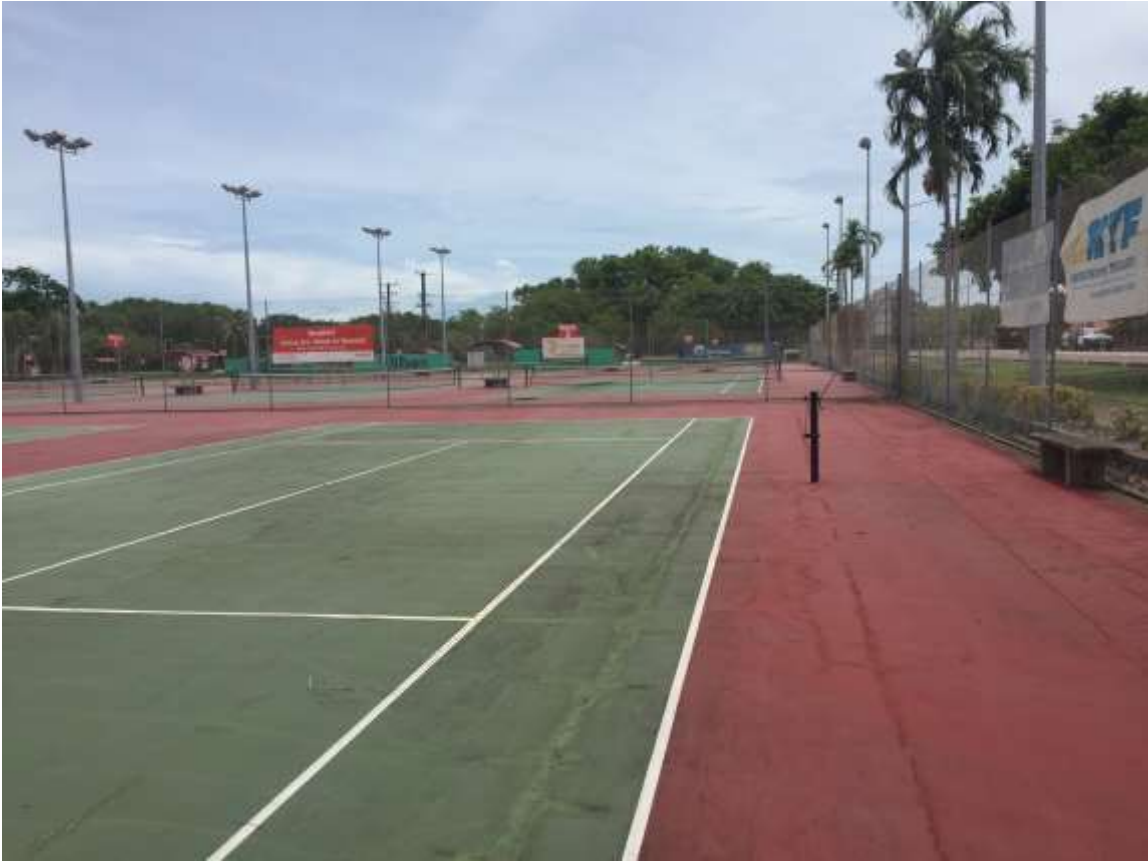
The tennis courts show surface cracking and distress in many areas with probably the worst area being around BH1. The distress comprises cracking (without vertical displacement) and some pitting and surface break-up. The boreholes have shown that the pavement thicknesses vary as do the materials used in the pavement. This may be a result of the somewhat sporadic development of the facility. It is therefore likely that the materials will vary in the different stages of court development.

Photo 1: Typical Cracking

The main likely cause of the pavement cracking and break-up is moisture change in the subgrade causing seasonal changes in movement. Although the soils are predominantly sand, the significant fluctuations in the groundwater table can cause pavements to crack. Corrosion in the aggregates in the pavement may also be a cause.

Superficial, yet cheaper, surface applications of new playing surfaces is regarded as a short term fix only. In the more distressed area we consider the best option will be to remedy the root causes of the problem namely improve the court surface and subsurface drainage. Also replacing and reprofiling the court surfaces should be considered to enhance the drainage and to strengthen the pavement. This will involve replacing some or all of the pavements.

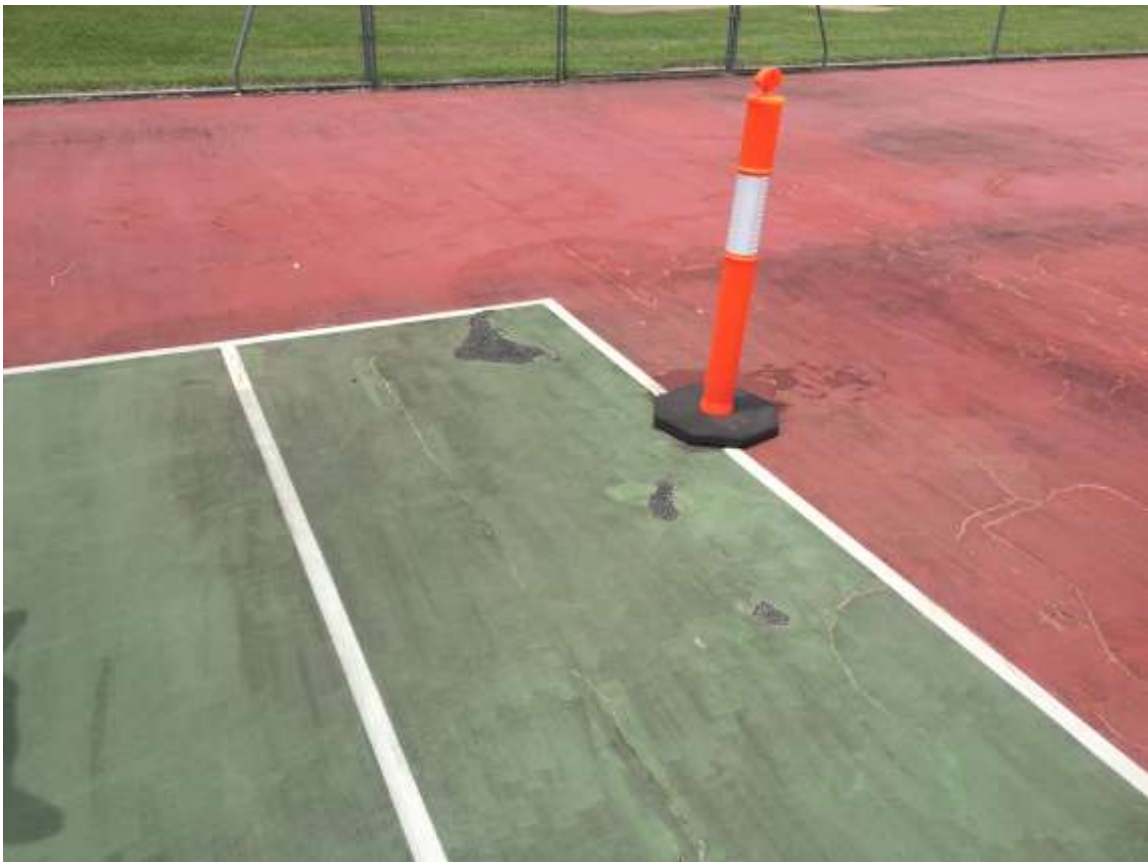
Photo 2: Cracking onsite
